WRIGHT WATER ENGINEERS, INC.

PUBLIC SAFETY AT LOW-HEAD DAMS

*By Kenneth R. Wright, P.E.,¹ T. Andrew Earles, Ph.D., P.E.,²
and Jonathan M. Kelly, P.E.³*

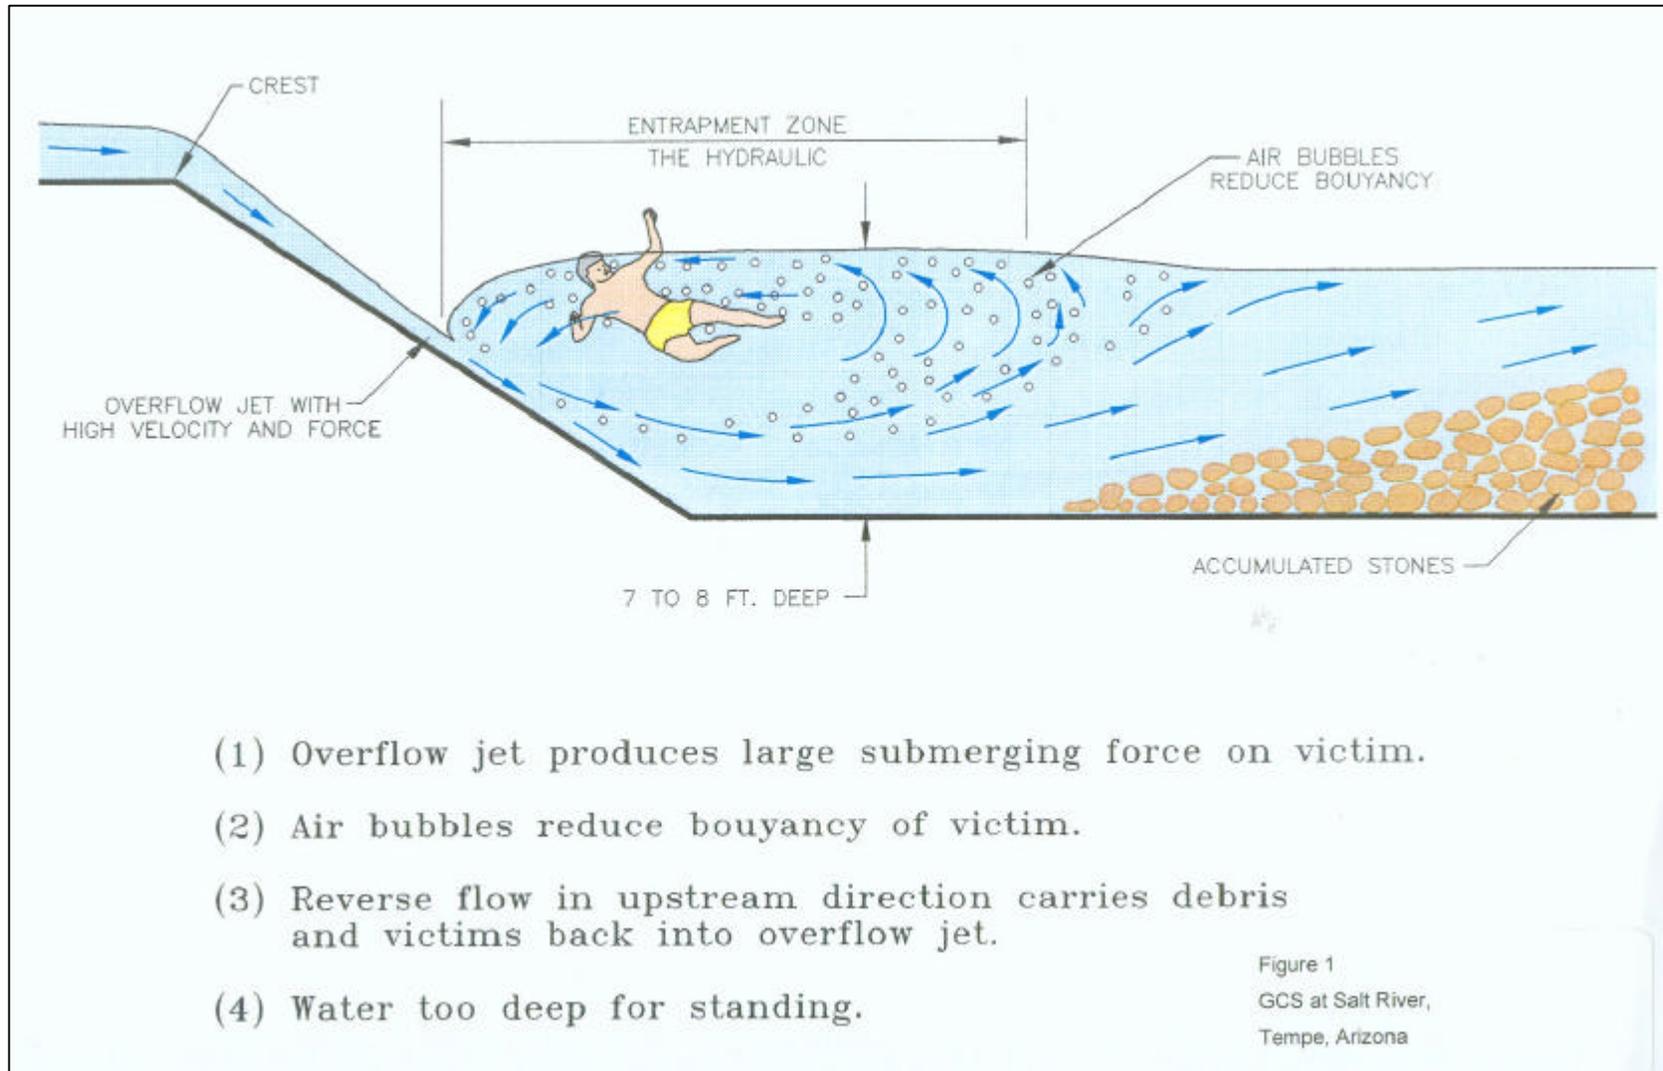
Figure 1 – GCS at Salt River Tempe, Arizona

As a result of a highway project and improvements to the channel of the Salt River through Tempe, Arizona, GCSs in a series were under construction in the 1991–1993 period to control bed erosion. One GCS, No. 5, immediately downstream of the McClintock Bridge, was built of compacted soil cement 378 feet with a height of 5 feet, with a stilling pool 64 feet long and 4 feet deep, as illustrated in Figure 1.

On a pleasant Sunday afternoon on March 25, 1993, four local men took a canoe ride: two men in each canoe. The Salt River had been flowing for several months. On this date, the flow was 4,090 cubic feet per second (cfs) with 3,500 cfs going over the partially completed GCS section, resulting in a unit discharge ranging from 9 to 17 cfs per foot of GCS length, the range being due to the crest sloping toward the river center.

From upstream, canoeists' view of the GCS water would have appeared rather tranquil, and the four canoeists proceeded over the crest. Although the first canoe passed over the structure successfully, the second canoe capsized, and its two occupants were drowned.

At the likely location where the two canoes passed over the GCS, the vertical hydraulic drop on March 25, 1993 was only 4 feet. The velocity of flow at the crest was about 9 fps, with a depth of 1.4 feet. Where the overflow jet met the downstream water surface, it had an estimated velocity of 17 fps, plunging into the stilling basin to create a submerged hydraulic jump. Kinetic energy in the submerged jet was maintained until the jet rose to the surface downstream of the crest where a boil was formed. Some of the jet flowed downstream and some flowed upstream, back towards the GCS face and the plunging jet. Based on photographs and video records, the water flow character downstream of the GCS appeared somewhat smooth and tranquil, but bubbles rising to the surface and some debris bobbing in the water at the downstream face of the GCS told another story; this was a drowning machine.

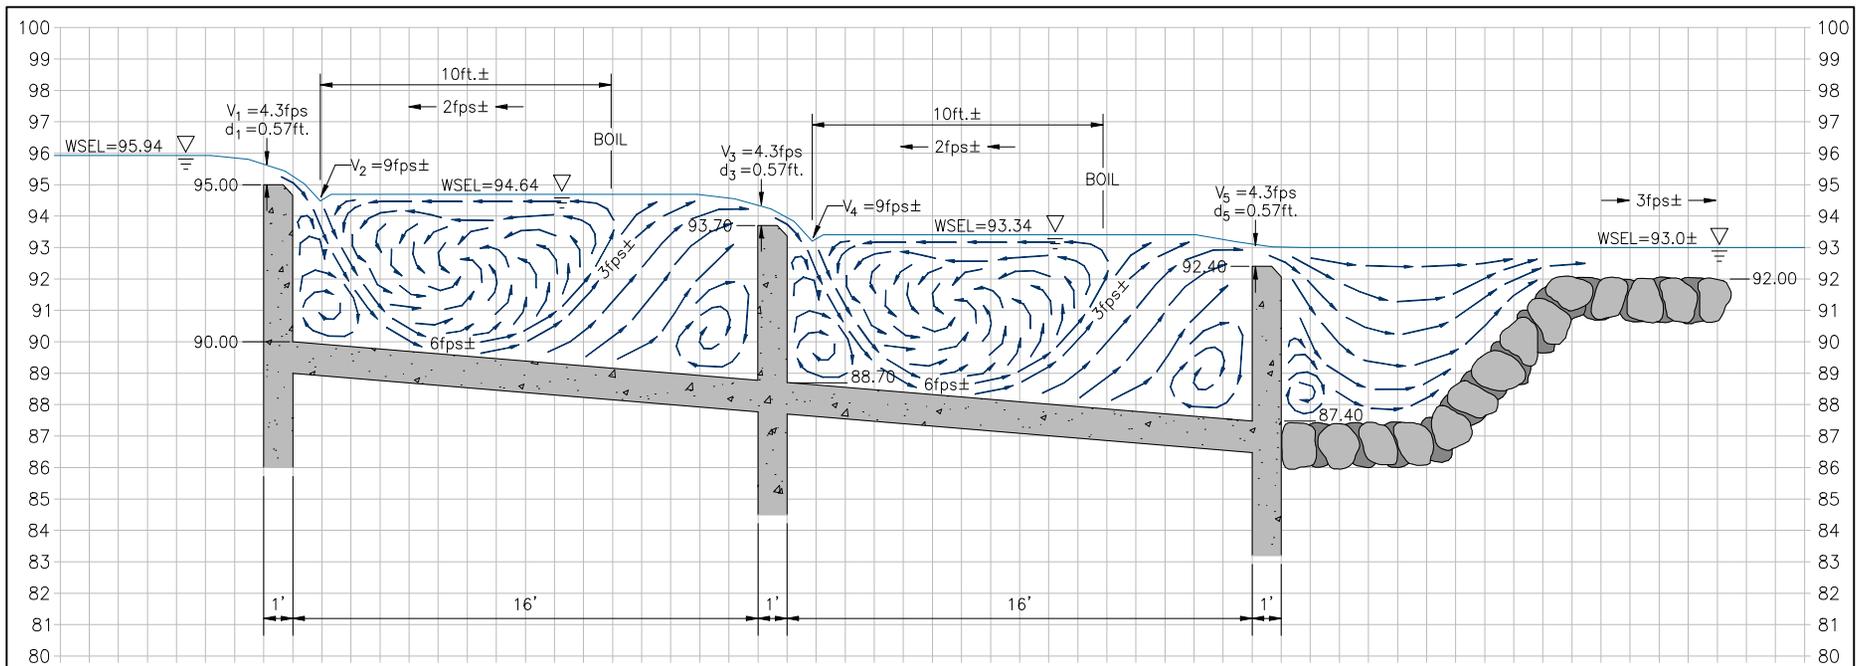
Figure 2 – Swackhammer Dam on Catherine Creek Near Union, Oregon

The tragic drowning of a mother and daughter near Union, Oregon on June 30, 1996 was caused by one or more reverse rollers, where the hydraulic drop from one set of weirs to another was only 1.3 feet. It was here on Catherine Creek that the old Swackhammer Dam was replaced with a modern drop structure to facilitate fish passage, as shown in Figure 2. The U.S. Bureau of Fisheries and the State of Oregon designed the structure; both neglected to consider hazards created by submerged hydraulic jump reverse rollers to the general public.

The total hydraulic drop across the new structure was only 2.9 feet at 160 cfs, the vertical drop being distributed over three concrete weirs in series. The flow velocity at each weir crest was 4.3 fps, while the jet velocity impinging on the lower water surface was 9 fps. Water depth in the pools was 5.6 feet, and the reverse roller was about 10 feet long. A relatively slow reverse current of 2.0 fps provided the hydraulic trap for the two victims.

While the Oregon stream classification for Catherine Creek included fishing, recreation, and water contact recreation, the new Swackhammer Dam was designed to provide for adequate fish passage and water diversion purposes, but without consideration for public safety.

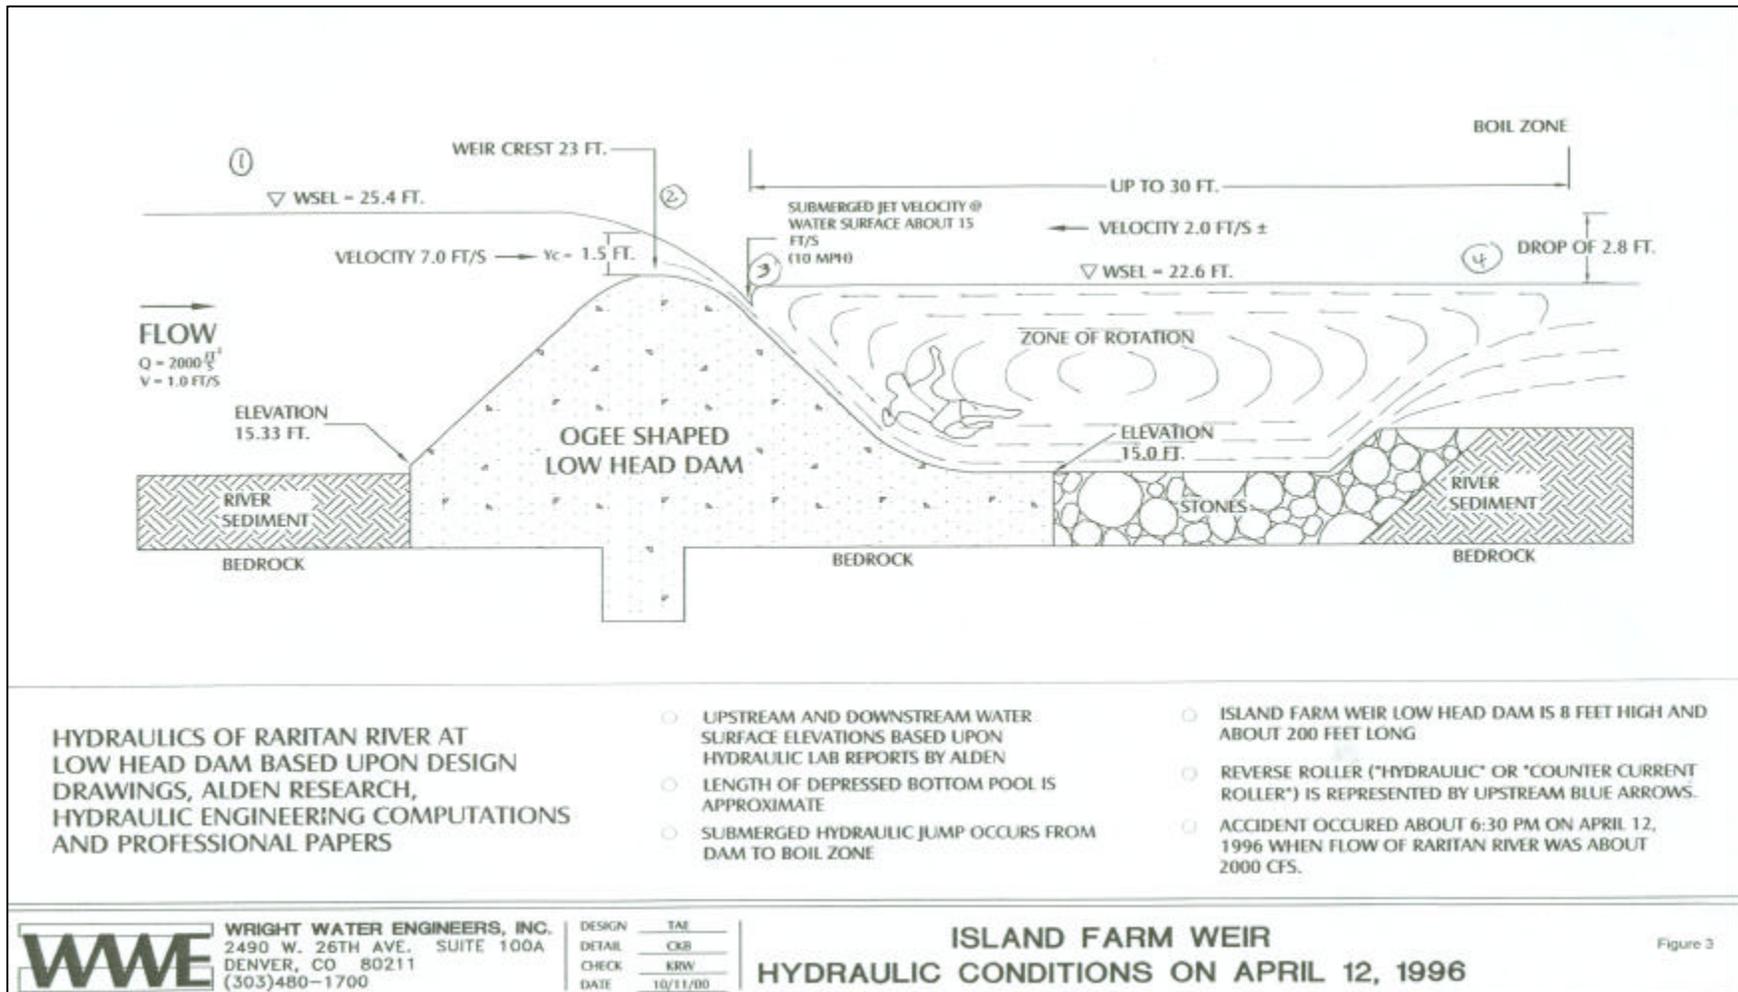
Figure 3 – Island Farm Weir Hydraulic Conditions on April 12, 1996

Even though the dam was 8 feet high, the hydraulic drop across the dam, from upstream to downstream, was only 2.8 feet, due to the stilling basin depth and the high tailwater conditions. At the crest of the dam, the velocity was 7 fps, with a depth of 1.55 feet. Meanwhile, where the overflow jet met the downstream pool, the velocity had increased to over 13 fps, with a Froude number of 2.8.

Figure 3 illustrates the dam and hydraulic characteristics at the time of the drowning and shows the length of the reverse roller at 30 feet, with an upstream velocity toward the dam of only a modest 2.0 fps; yet the current was able to trap the victim causing his expiration and the injury of two companions.

The Island Farm Weir was finally retrofitted in 1998 after four drownings in only three years following its construction. The successful retrofit consisted of merely flattening the downstream face of the dam by providing a series of steps to dissipate energy and to eliminate the opportunity for a reverse roller to form below the dam structure.

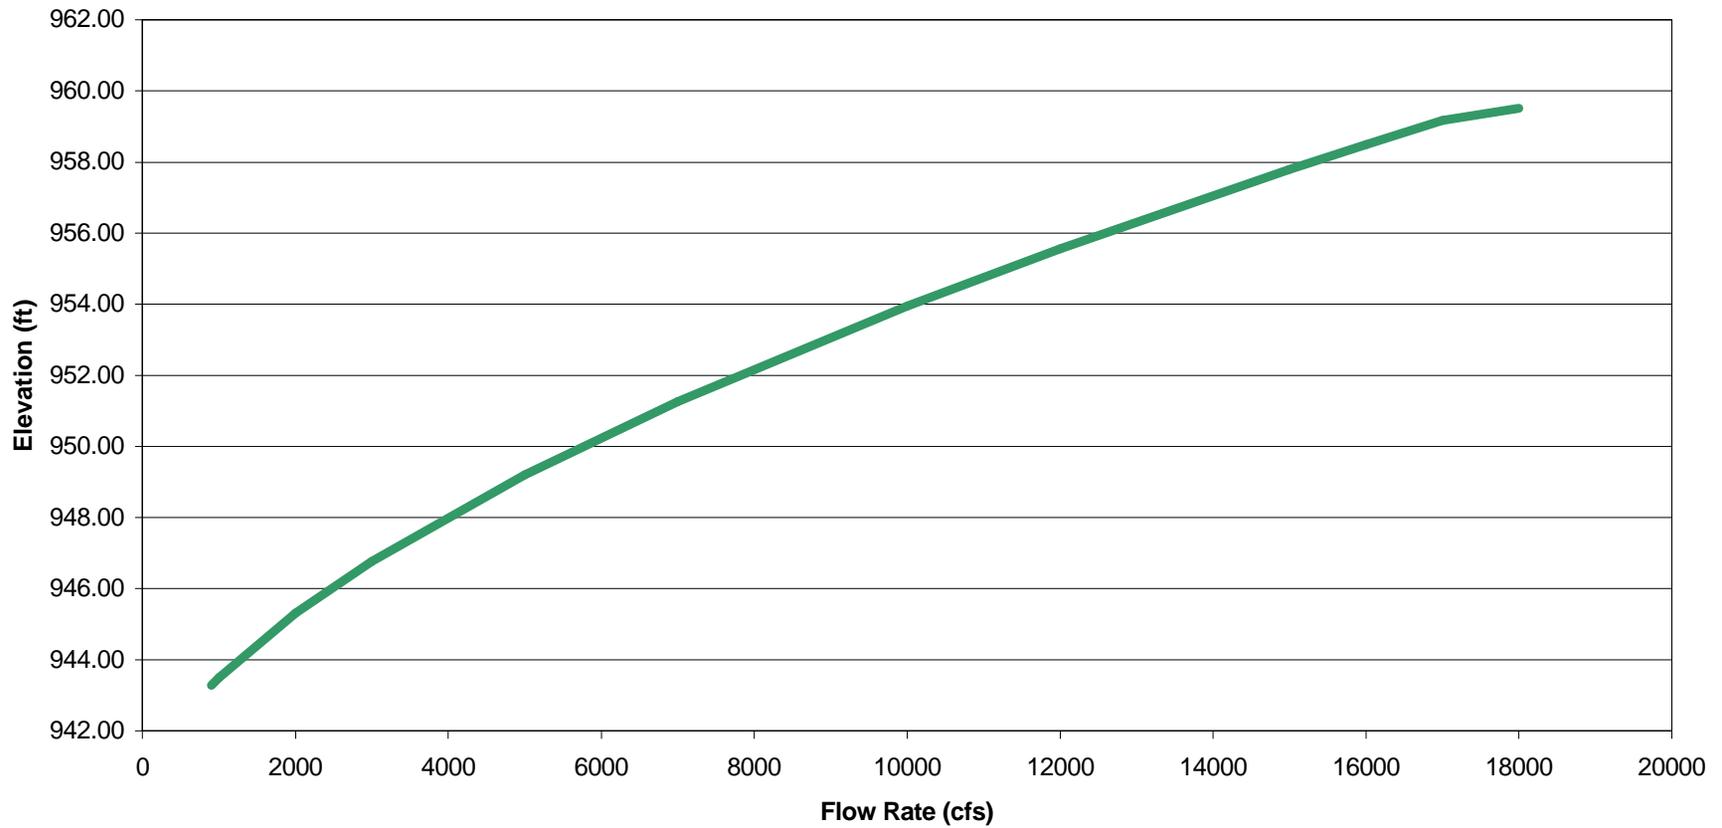
Figure 4 – Tailwater Elevation Rating Curve for Highland Dam

At the time of the incident, the depth of the flow over the crest was 0.97 feet at a velocity of 4.0 fps. The tailwater elevation was 7.9 feet below the dam crest with a vertical upstream-downstream water surface drop of 8.9 feet and a jet velocity of 24.2 fps where the jet plunged into the downstream pool (Froude number of 9.0). The jet surfaced approximately 40 feet downstream of the dam at a boil, where the remaining kinetic energy in the jet caused a small water surface rise with bubbles, with a portion of the jet flowing upstream at a relatively high velocity of 6.5 fps. The tailwater rating curve and the submerged hydraulic jump characteristics are presented in Figures 4 and 5.

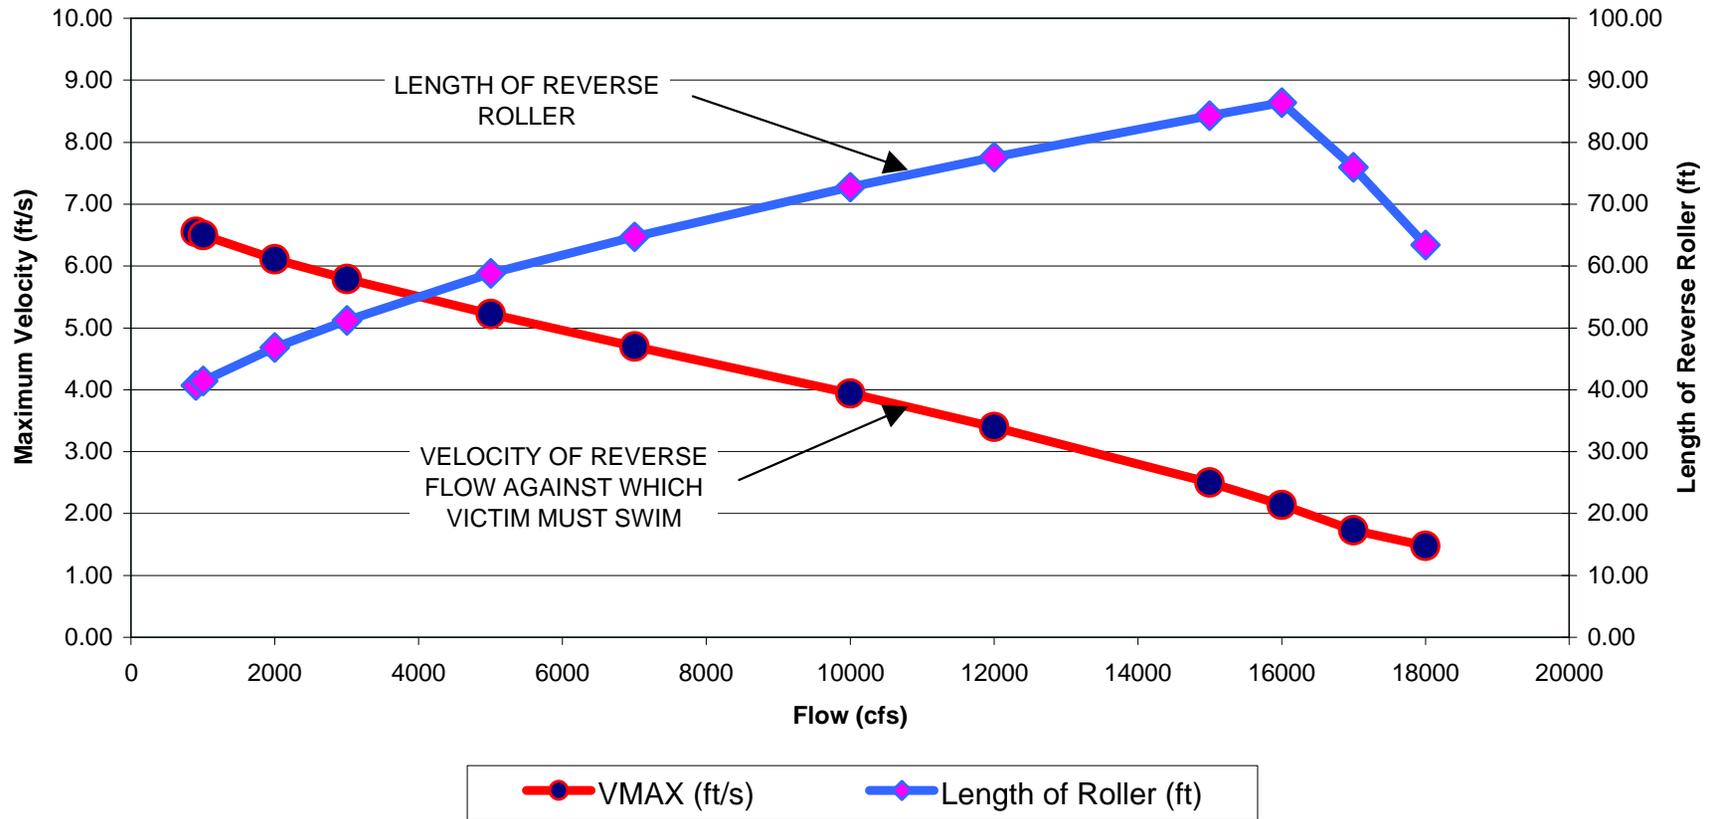
Figure 5 –Highland Dam, West Fork River Submerged Hydraulic Jump Characteristics

When the 15-foot canoe overturned upstream of the boil, the three occupants were carried to the base of the dam by the reverse current, where they encountered the force of the spillway jet, causing them to be submerged along with the plunging jet, only to be carried downstream, rising to the surface near the boil and then being carried back to the face of the dam in a continuing cycle. All three of the canoeists drowned at the base of the Highland Dam on the West Fork River that was classified by the State of West Virginia for recreation, including boating. There were not warning signs above or below the dam to warn recreationists.

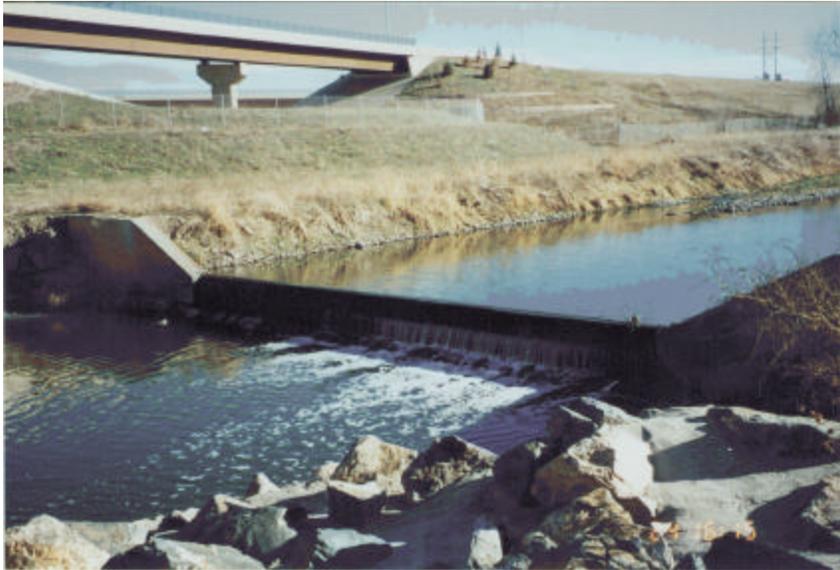
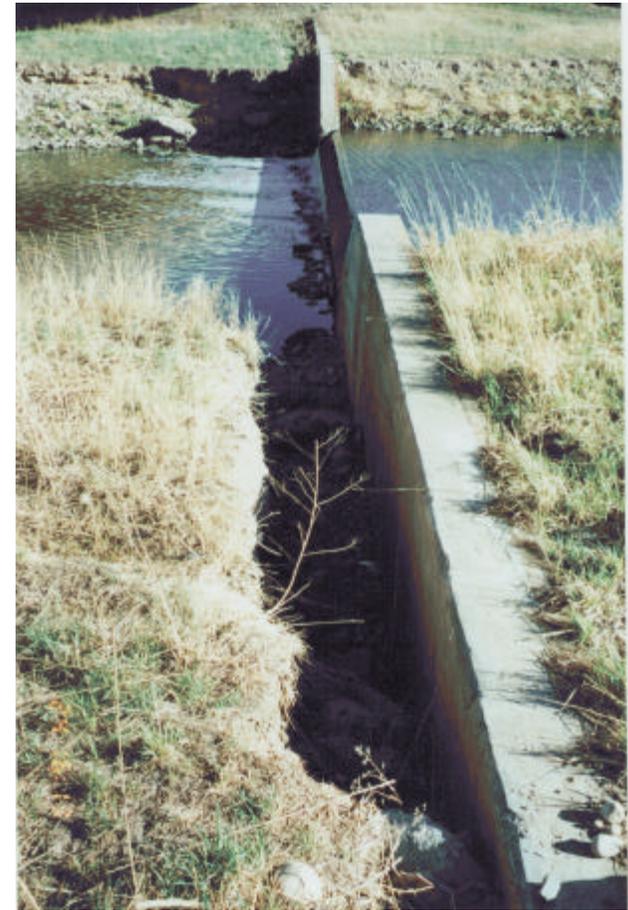
Figure 6 - Photos of GCS Structure in Adams County, Colorado

The Colorado Department of Transportation (CDOT) constructed three low-head GCS structures in series in Clear Creek under Interstate 25 during 1991 and 1992. On June 30, 1996, a man and wife floated down Clear Creek in Adams County, along with another couple; upon encountering the first GCS, their raft capsized, and the first couple was tragically drowned. The second couple survived. The stream flow was about 700 cfs at the time of the incident. The GCS structure is shown in Figure 6.

In May 1992 prior to the accident, the director of the local county Parks and Recreation Department wrote to CDOT informing them of the hazardous nature of the GCS design and construction. By June 1998, the three GCS structures were retrofitted by creating a 1:10 sloping, grouted, riprap surface downstream of each crest. This created enough of a horizontal flow vector, hydraulic roughness, and shallow enough flow depth immediately below each structure so that reverse rollers no longer form.

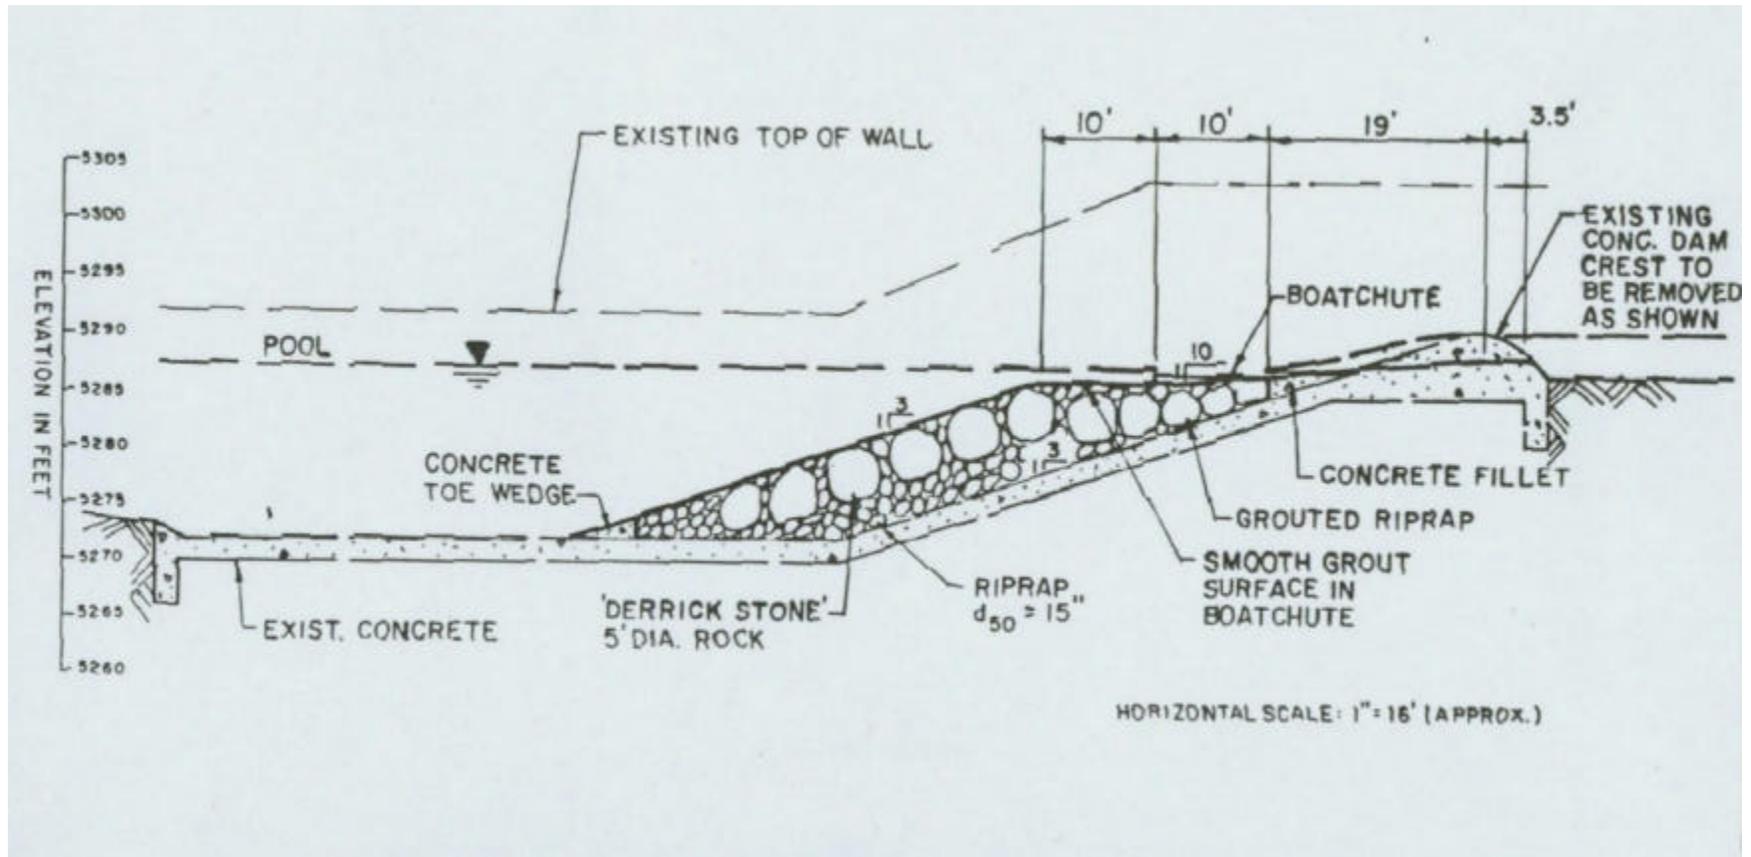
Figure 7 – Boating Improvements to Union Avenue Dam (Section Thru Existing Dam)

When the USACE replaced the historic St. Petersburg Ditch diversion dam in 1985 on the South Platte River with a new structure, they did not give adequate consideration to the pre-design period recommendations of local recreational boaters. The new structure was called the Union Avenue Dam. Its profile is shown in Figure 7.

The new dam was an 18.5 feet high, concrete gravity dam with an over-the-dam spillway that sloped at 33 percent into a stilling basin, the hydraulic drop being 15 feet. Typical spring river flows over the dam of 700 cfs, and even up to higher flows such as 1,300 cfs, gave the sound and appearance of a good whitewater rafting experience, and the stilling basin provided an attractive urban setting for recreationists to practice hazard maneuvers. The South Platte River classification by the State of Colorado included recreational uses.

During the three years (1985-1988) following the new dam completion, three boaters drowned. At this point, it was obvious that a public water hazard had been created. The USACE and the state wanted to cure this hazardous public works problem.

The solution was to build a boat chute near the right abutment and to flood the downstream face of the dam with a series of four downstream stair-stepped embankments so that each hydraulic drop would be only 3 to 4 feet high, and each embankment would include a designed boat chute that would safely convey recreational boaters without a reverse roller being formed.

Fortunately, the state agency was willing to have the design tested using a 1:18 hydraulic model built by the U.S. Bureau of Reclamation's hydraulic laboratory at the Denver Federal Center. The extensive model testing effort also included the placement of rock fill on the downstream face of the dam to eliminate dangerous currents, even during higher flow periods when discharges exceeded the boat chute flow. Their thorough and comprehensive model study and report by Klumpp, Pugh, and Fitzwater (1989) was highly successful; the resulting retrofit of the Union Avenue Dam converted a serious public hazard into a popular water recreational park.
