WRIGHT WATER ENGINEERS, INC.

PUBLIC SAFETY AT LOW-HEAD DAMS

Abstract

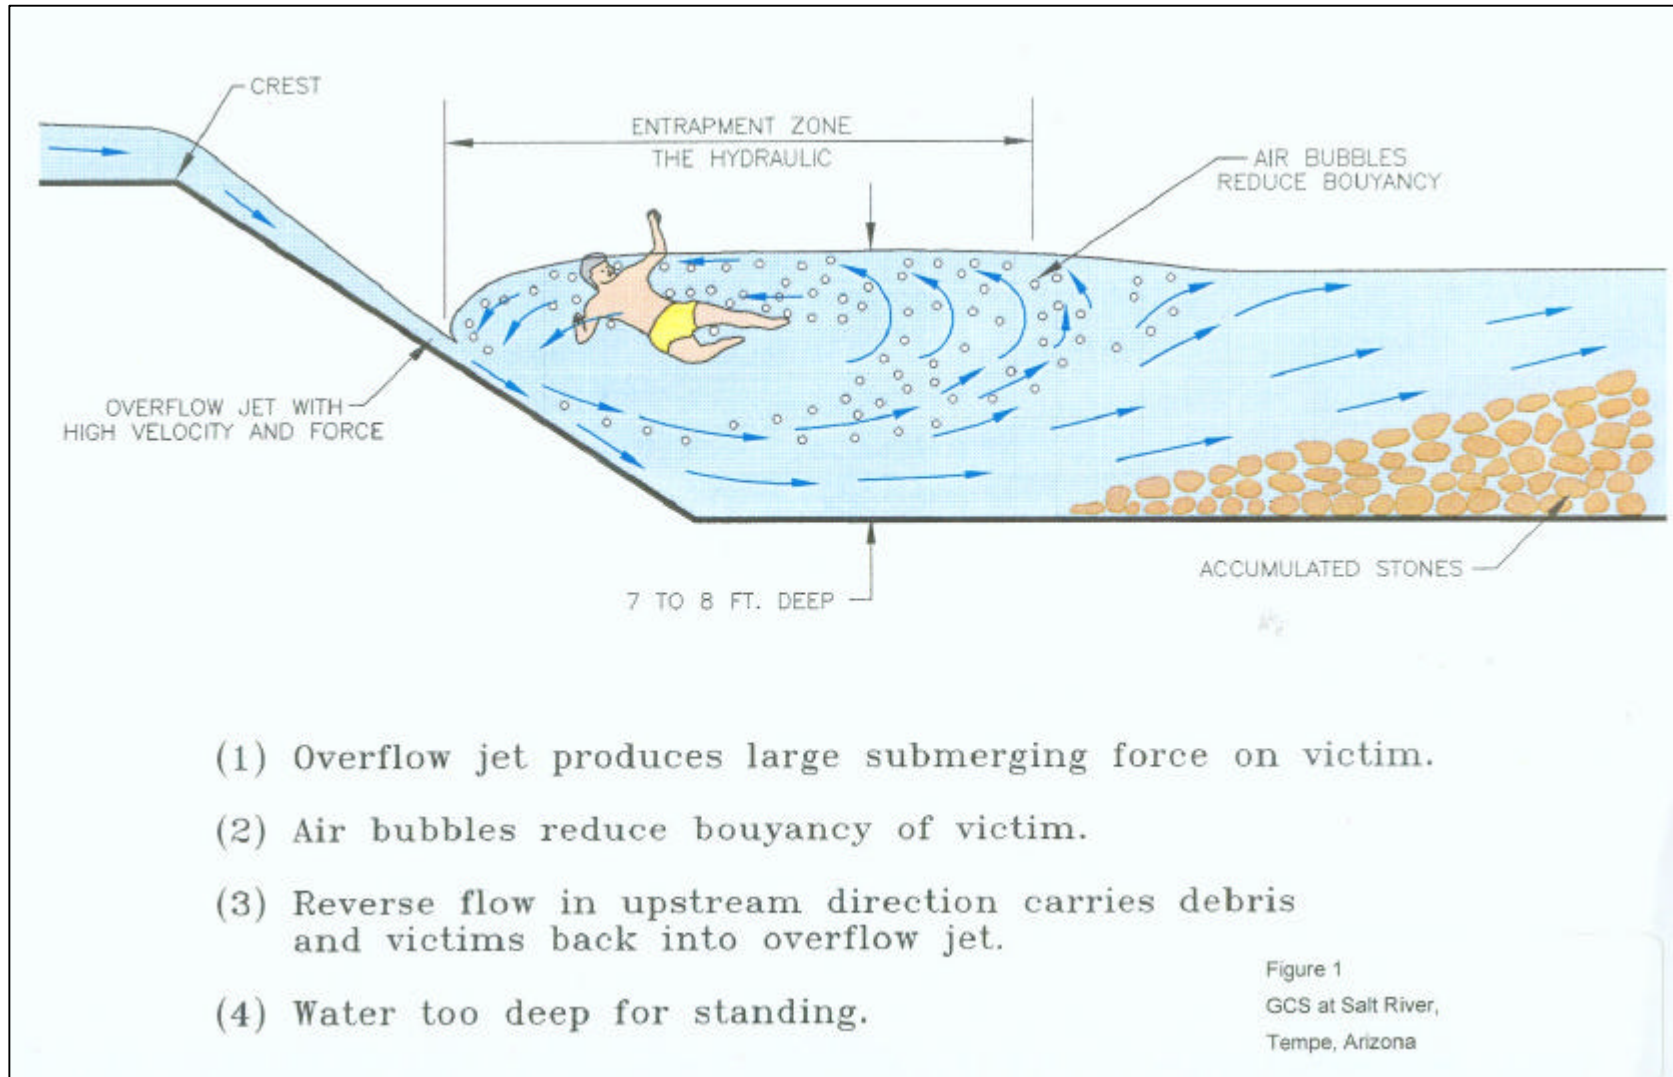
Figure 1 – GCS at Salt River Tempe, Arizona

As a result of a highway project and improvements to the channel of the Salt River through Tempe, Arizona, GCSs in a series were under construction in the 1991–1993 period to control bed erosion. One GCS, No. 5, immediately downstream of the McClintock Bridge, was built of compacted soil cement 378 feet with a height of 5 feet, with a stilling pool 64 feet long and 4 feet deep, as illustrated in Figure 1.

At the likely location where the two canoes passed over the GCS, the vertical hydraulic drop on March 25, 1993 was only 4 feet. The velocity of flow at the crest was about 9 fps, with a depth of 1.4 feet. Where the overflow jet met the downstream water surface, it had an estimated velocity of 17 fps, plunging into the stilling basin to create a submerged hydraulic jump. Kinetic energy in the submerged jet was maintained until the jet rose to the surface downstream of the crest where a boil was formed. Some of the jet flowed downstream and some flowed upstream, back towards the GCS face and the plunging jet. Based on photographs and video records, the water flow character downstream of the GCS appeared somewhat smooth and tranquil, but bubbles rising to the surface and some debris bobbing in the water at the downstream face of the GCS told another story; this was a drowning machine.

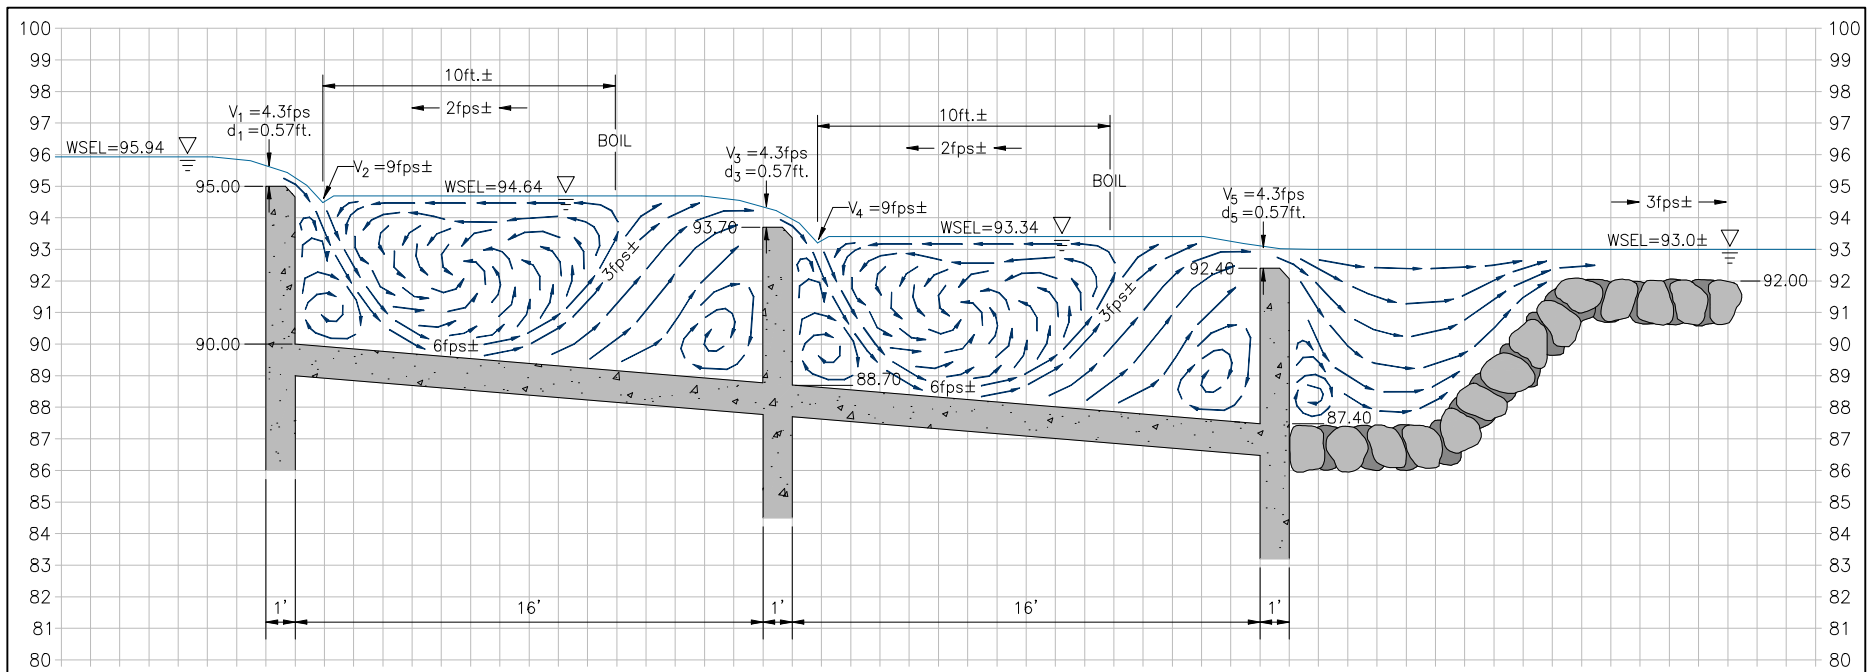
Figure 2 – Swackhammer Dam on Catherine Creek Near Union, Oregon

The tragic drowning of a mother and daughter near Union, Oregon on June 30, 1996 was caused by one or more reverse rollers, where the hydraulic drop from one set of weirs to another was only 1.3 feet. It was here on Catherine Creek that the old Swackhammer Dam was replaced with a modern drop structure to facilitate fish passage, as shown in Figure 2. The U.S. Bureau of Fisheries and the State of Oregon designed the structure; both neglected to consider hazards created by submerged hydraulic jump reverse rollers to the general public.

The total hydraulic drop across the new structure was only 2.9 feet at 160 cfs, the vertical drop being distributed over three concrete weirs in series. The flow velocity at each weir crest was 4.3 fps, while the jet velocity impinging on the lower water surface was 9 fps. Water depth in the pools was 5.6 feet, and the reverse roller was about 10 feet long. A relatively slow reverse current of 2.0 fps provided the hydraulic trap for the two victims.

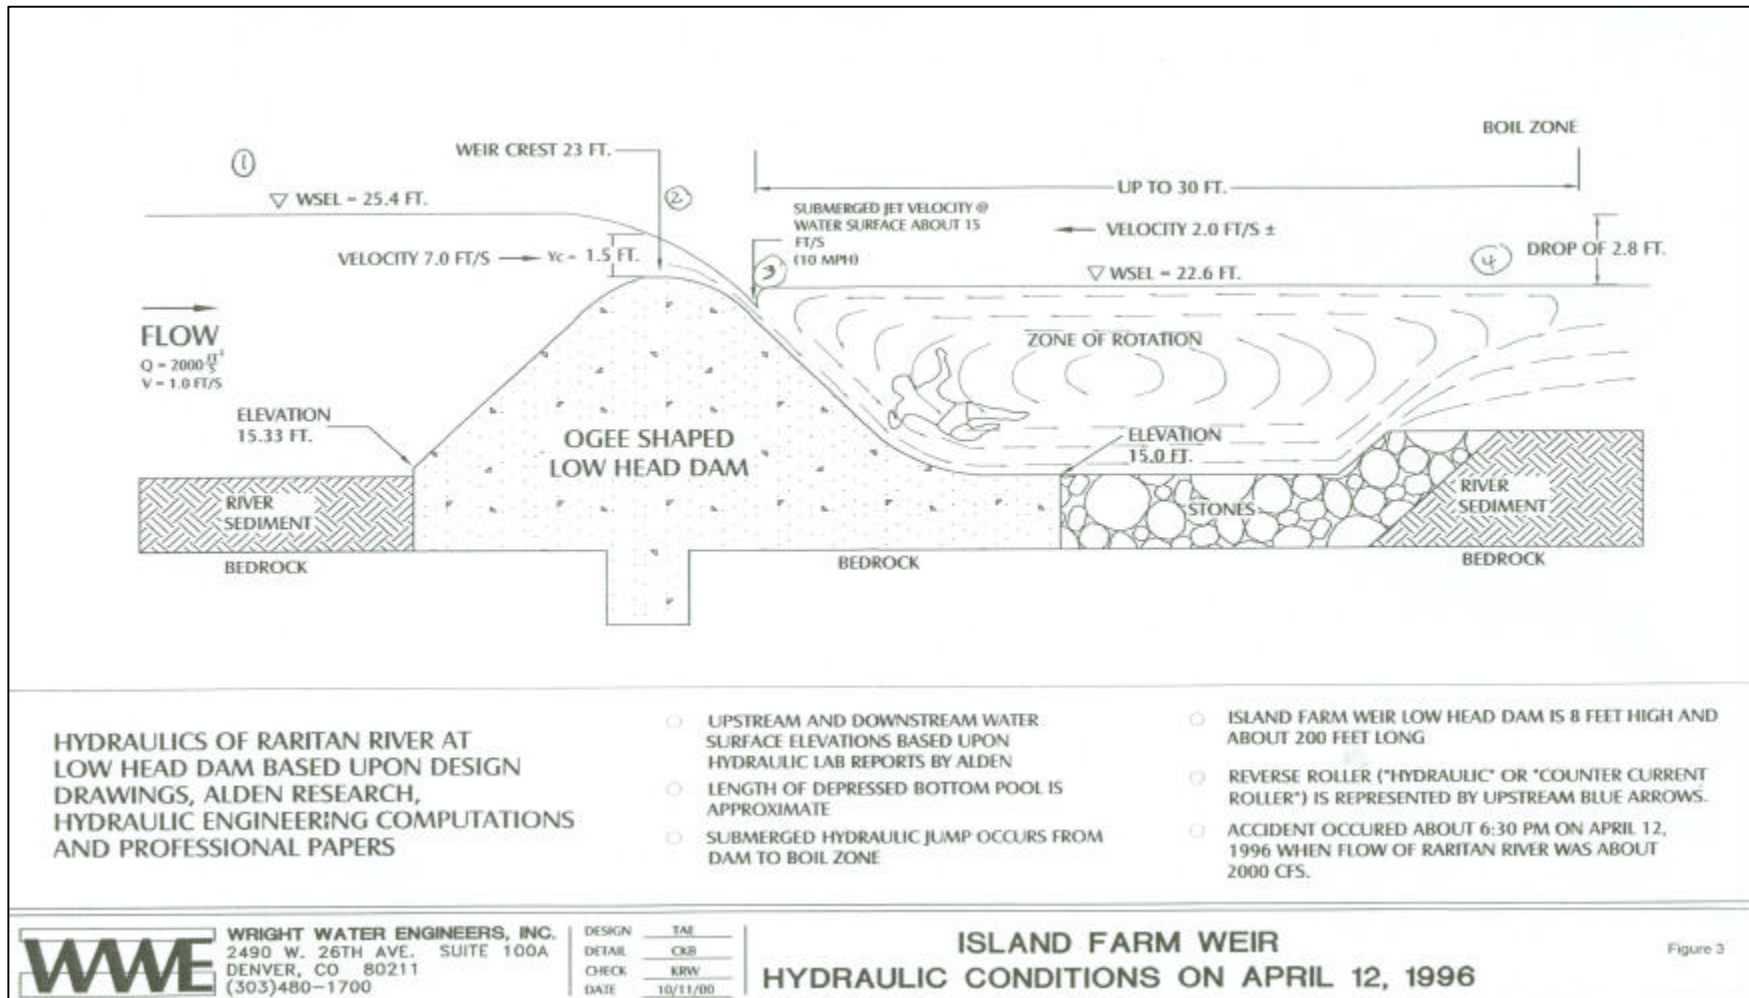
Figure 3 – Island Farm Weir Hydraulic Conditions on April 12, 1996

Even though the dam was 8 feet high, the hydraulic drop across the dam, from upstream to downstream, was only 2.8 feet, due to the stilling basin depth and the high tailwater conditions. At the crest of the dam, the velocity was 7 fps, with a depth of 1.55 feet. Meanwhile, where the overflow jet met the downstream pool, the velocity had increased to over 13 fps, with a Froude number of 2.8.

Figure 3 illustrates the dam and hydraulic characteristics at the time of the drowning and shows the length of the reverse roller at 30 feet, with an upstream velocity toward the dam of only a modest 2.0 fps; yet the current was able to trap the victim causing his expiration and the injury of two companions.

The Island Farm Weir was finally retrofitted in 1998 after four drownings in only three years following its construction. The successful retrofit consisted of merely flattening the downstream face of the dam by providing a series of steps to dissipate energy and to eliminate the opportunity for a reverse roller to form below the dam structure.

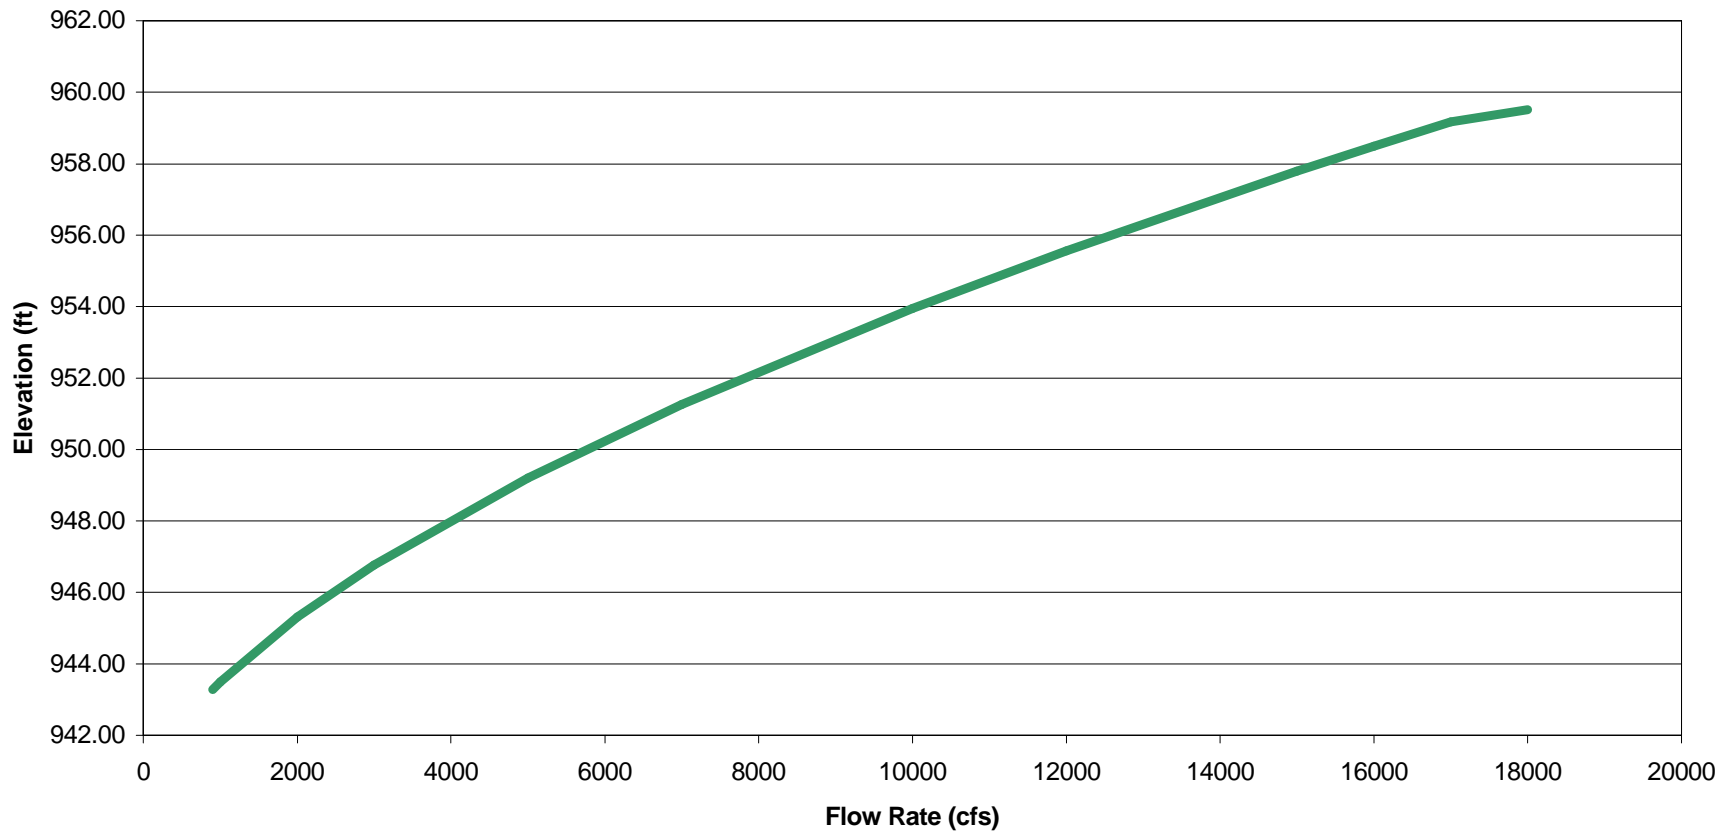
Figure 4 – Tailwater Elevation Rating Curve for Highland Dam

At the time of the incident, the depth of the flow over the crest was 0.97 feet at a velocity of 4.0 fps. The tailwater elevation was 7.9 feet below the dam crest with a vertical upstream-downstream water surface drop of 8.9 feet and a jet velocity of 24.2 fps where the jet plunged into the downstream pool (Froude number of 9.0). The jet surfaced approximately 40 feet downstream of the dam at a boil, where the remaining kinetic energy in the jet caused a small water surface rise with bubbles, with a portion of the jet flowing upstream at a relatively high velocity of 6.5 fps. The tailwater rating curve and the submerged hydraulic jump characteristics are presented in Figures 4 and 5.

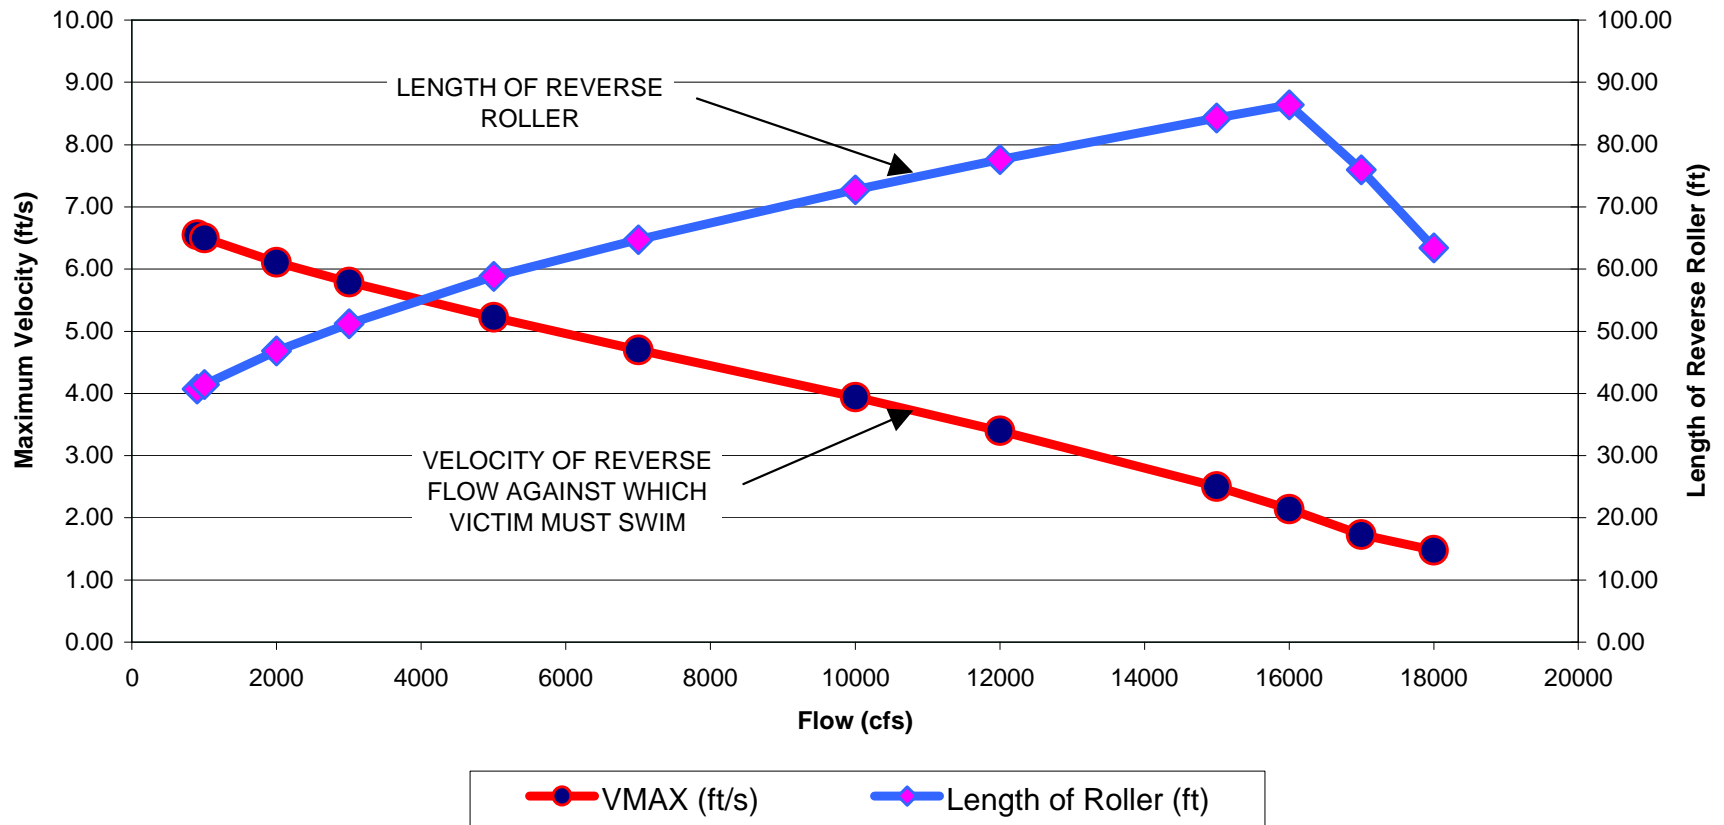
Figure 5 –Highland Dam, West Fork River Submerged Hydraulic Jump Characteristics

When the 15-foot canoe overturned upstream of the boil, the three occupants were carried to the base of the dam by the reverse current, where they encountered the force of the spillway jet, causing them to be submerged along with the plunging jet, only to be carried downstream, rising to the surface near the boil and then being carried back to the face of the dam in a continuing cycle. All three of the canoeists drowned at the base of the Highland Dam on the West Fork River that was classified by the State of West Virginia for recreation, including boating. There were not warning signs above or below the dam to warn recreationists.

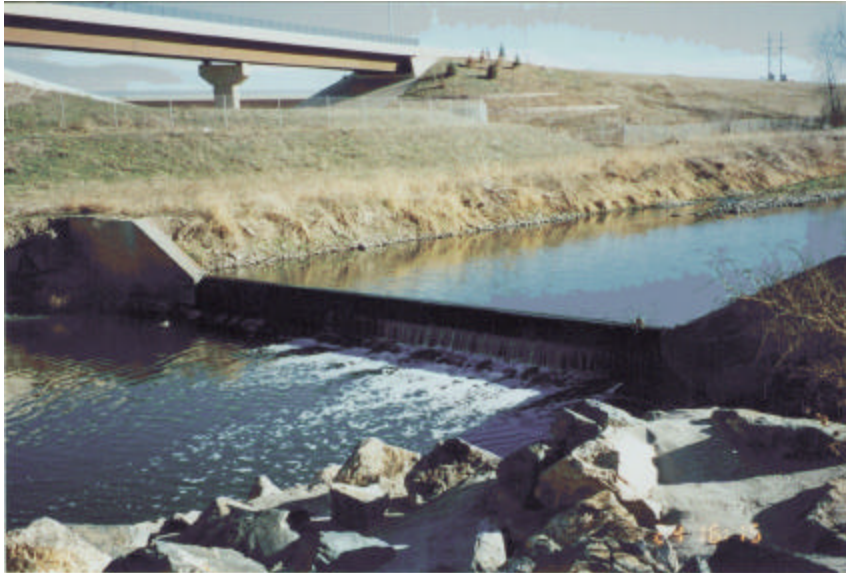
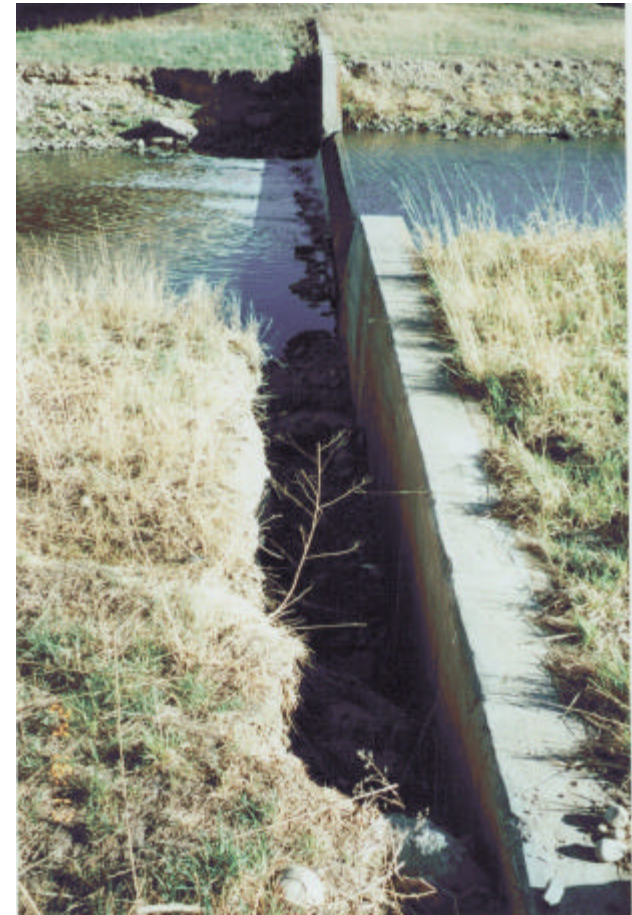
Figure 6 - Photos of GCS Structure in Adams County, Colorado

The Colorado Department of Transportation (CDOT) constructed three low-head GCS structures in series in Clear Creek under Interstate 25 during 1991 and 1992. On June 30, 1996, a man and wife floated down Clear Creek in Adams County, along with another couple; upon encountering the first GCS, their raft capsized, and the first couple was tragically drowned. The second couple survived. The stream flow was about 700 cfs at the time of the incident. The GCS structure is shown in Figure 6.

In May 1992 prior to the accident, the director of the local county Parks and Recreation Department wrote to CDOT informing them of the hazardous nature of the GCS design and construction. By June 1998, the three GCS structures were retrofitted by creating a 1:10 sloping, grouted, riprap surface downstream of each crest. This created enough of a horizontal flow vector, hydraulic roughness, and shallow enough flow depth immediately below each structure so that reverse rollers no longer form.

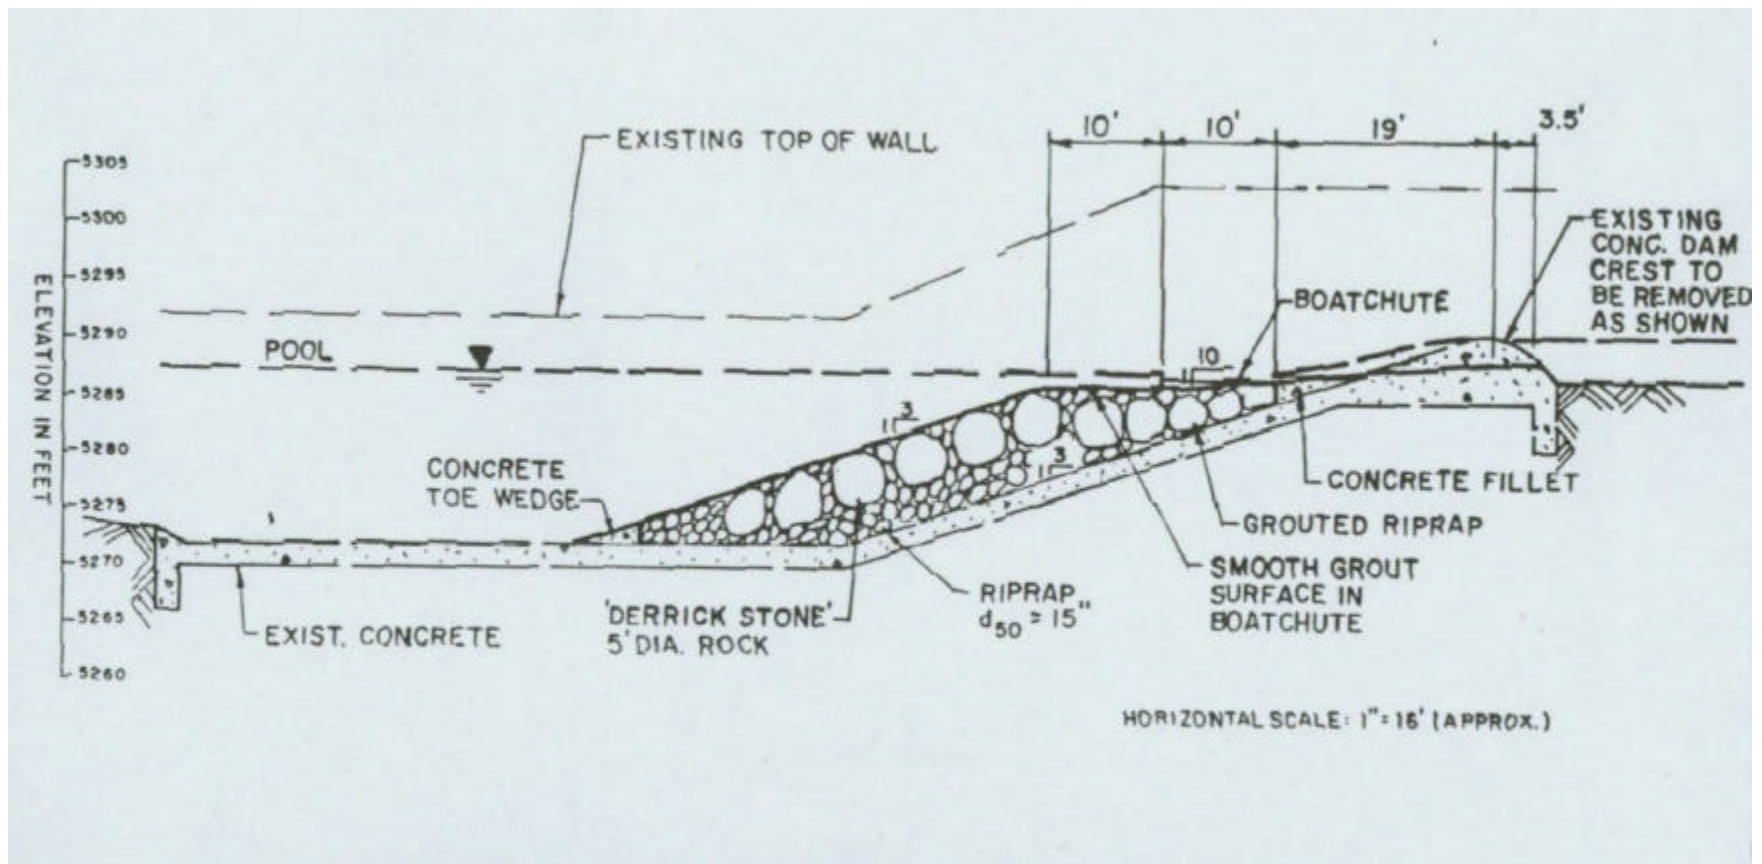
Figure 7 – Boating Improvements to Union Avenue Dam (Section Thru Existing Dam)

When the USACE replaced the historic St. Petersburg Ditch diversion dam in 1985 on the South Platte River with a new structure, they did not give adequate consideration to the pre-design period recommendations of local recreational boaters. The new structure was called the Union Avenue Dam. Its profile is shown in Figure 7.

The new dam was an 18.5 feet high, concrete gravity dam with an over-the-dam spillway that sloped at 33 percent into a stilling basin, the hydraulic drop being 15 feet. Typical spring river flows over the dam of 700 cfs, and even up to higher flows such as 1,300 cfs, gave the sound and appearance of a good whitewater rafting experience, and the stilling basin provided an attractive urban setting for recreationists to practice hazard maneuvers. The South Platte River classification by the State of Colorado included recreational uses.

The solution was to build a boat chute near the right abutment and to flood the downstream face of the dam with a series of four downstream stair-stepped embankments so that each hydraulic drop would be only 3 to 4 feet high, and each embankment would include a designed boat chute that would safely convey recreational boaters without a reverse roller being formed.

Fortunately, the state agency was willing to have the design tested using a 1:18 hydraulic model built by the U.S. Bureau of Reclamation's hydraulic laboratory at the Denver Federal Center. The extensive model testing effort also included the placement of rock fill on the downstream face of the dam to eliminate dangerous currents, even during higher flow periods when discharges exceeded the boat chute flow. Their thorough and comprehensive model study and report by Klumpp, Pugh, and Fitzwater (1989) was highly successful; the resulting retrofit of the Union Avenue Dam converted a serious public hazard into a popular water recreational park.
