# THE JOURNAL OF Dam Safety

VOLUME 9 | ISSUE 1 | 2011

# Hidden Dangers and Public Safety at Low-head Dams

BRUCE A. TSCHANTZ, PE

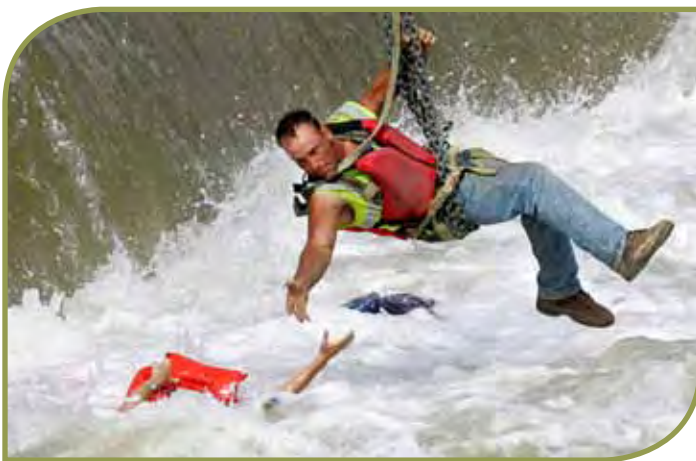
Figure 1 shows a dramatic June 30, 2009 rescue below a low-head dam on the Des Moines River, Des Moines, Iowa, where drownings have occurred.

**Figure 1. Photo by Mary Chind, Copyright 2009, The Des Moines Register and Tribune Company. Reprinted with permission.**

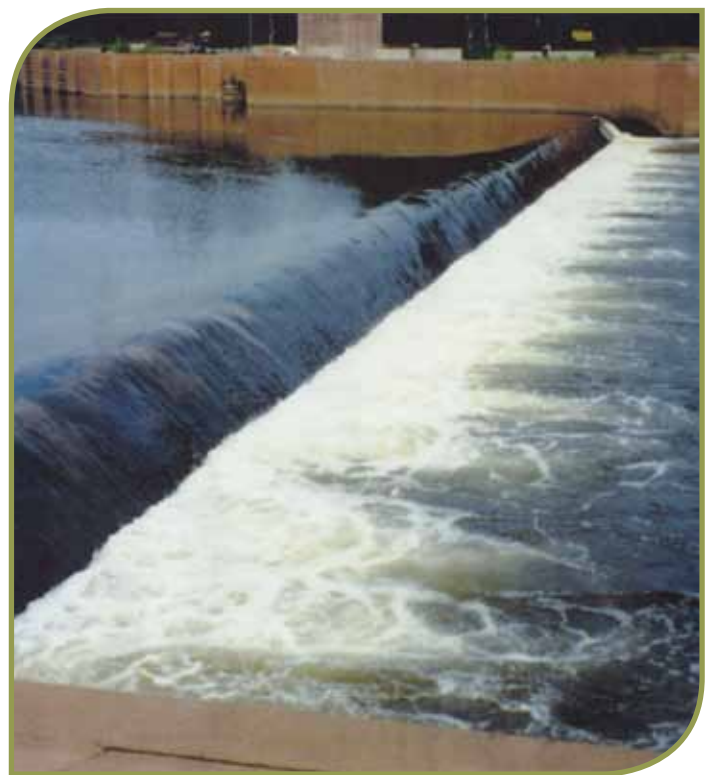
**Figure 5. Original Island Farm Weir**

Island Farm Weir Dam was constructed across the Raritan River, as shown in Figure 5, in 1995 to raise the water level to improve water supply drafting during low flow conditions. The Raritan River is classified by New Jersey as being suitable for recreational uses, including boating. No warning signs had been installed on the landings for boaters or other water users. On April 12, 1996, a canoer who had paddled over the dam crest and through the hydraulic was drowned in the recirculation flow of the reverse roller while attempting to rescue a comrade who had gone over the dam in his kayak and capsized. The kayaker and another person in the canoe eventually made it out with the help of a fisherman, but the victim’s body was never found. The river discharge on this date was estimated to be about 2,000 cfs over the 200-foot-long, 8-foot-high, ogee-shaped low-head dam.

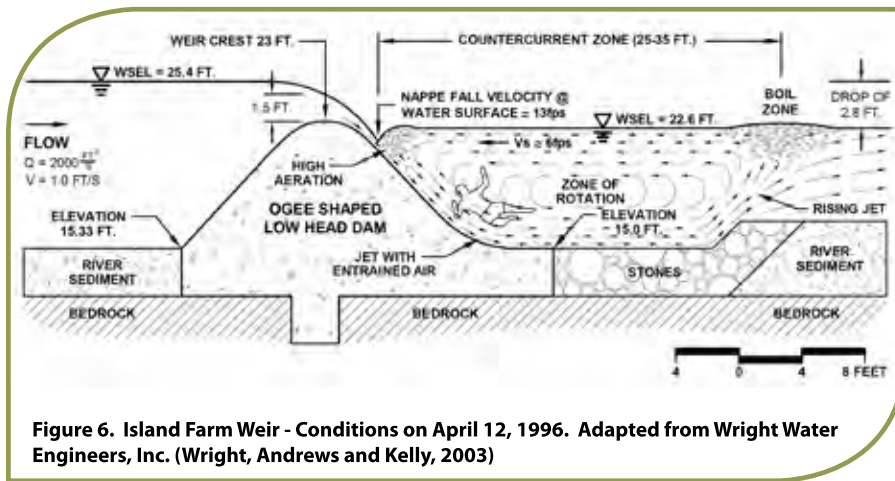
Hydraulic analysis shows that for a tailwater depth of 7.6 feet and a head of 2.4 ft over the 8-ft high dam, the Froude Number, initial hydraulic jump depth, and incoming velocity of the submerged jump were about 5.0, 0.6 ft, and 21 ft/sec, respectively. These conditions are capable of producing a sequent jump depth of about 4 ft and a tailwater submergence,  $S \approx 0.9$ . For this degree of submergence and surface water drop over the dam of only 2.8 feet, the reversed surface velocity toward the dam was almost 5 ft/sec. The length of the countercurrent velocity zone between the overflowing nappe and “boil” point is estimated to have been between 25 and 35 feet, or approximately 30 feet.

Figure 6 illustrates the dam and hydraulic characteristics at the time of the drowning. The strength of the countercurrent and overpowering nappe force, estimated at about 260 lbs, was apparently enough to drive the victim downward, entrap him, and ultimately cause his death.

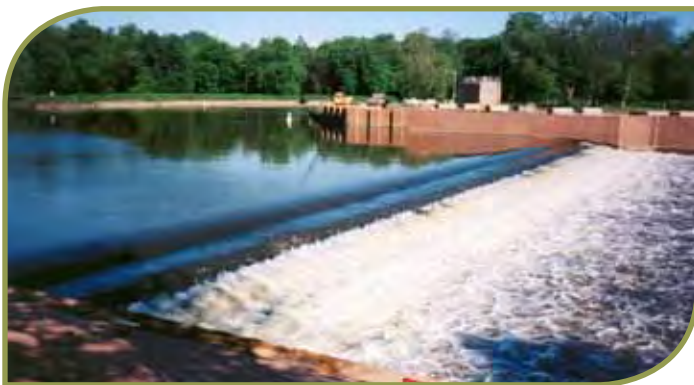
**Figure 7. Island Farm Weir stepped spillway modification.**

The Island Farm Weir was modified in 1998 after four drownings and three near-drownings in only three years following its construction. The successful retrofit consisted of providing a series of steps on the downstream face (Figure 7) to dissipate energy and to eliminate the opportunity for a submerged jump and reverse roller to form below the dam structure.

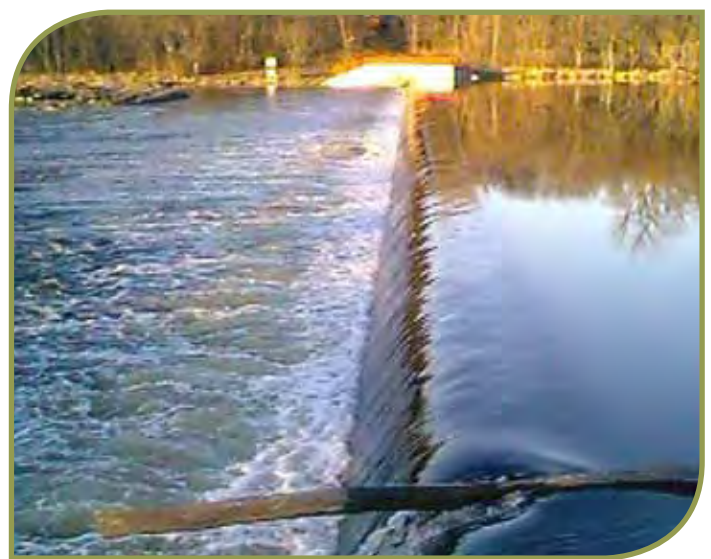
While accidents and drownings at low-head dams are reported regularly in the local and national media, little statistical data is available to assess the full national extent of the problem. Minnesota's Boat and Water Safety Section of the Department of Natural Resources reports 52 deaths and 50 injured or rescued people at low-head dams in that state between 1974 and 2002 (Minn., 2003). In Illinois, the Fox River has a notoriously dangerous segment of 15 dams in the 115-mile reach, just west of Chicago, between Wisconsin and its mouth at the Illinois River. At the 7-foot high Yorkville Dam (Figure 8), at least 12 people are reported to have drowned since it

**Figure 8. Yorkville Dam on the Fox River.**
