# **Twenty-Year Engineering Assessment** of an LID Facility in Boulder, CO

BY JONATHAN JONES, NATALIE PHARES, WILLIAM WENK. JORGE FIGUEROA, MELISSA FIGURSKI, AND EMILY BARNES

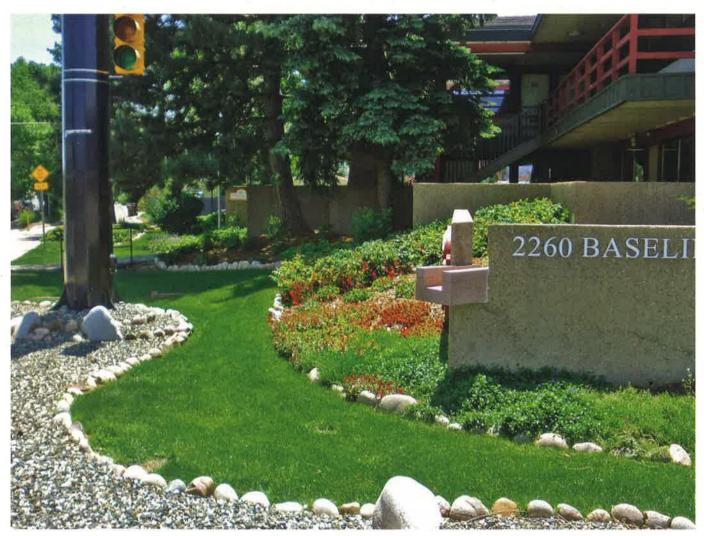
Figure 5. East building edge landscape following landscape renovation with drought-tolerant turfgrass and more ornamental xeriscape landscape plantings. Date: approximately 2008.

North and East Building Landscape Buffer. Conversion of the native riparian and upland grass and sedge swale at the northern and eastern building edge into the turf has increased levels of water use. This has likely reduced the effectiveness of the swale to infiltrate stormwater. (Even so, the stormwater swale appears to be largely functioning as designed, even with the non-native turf retrofit; it collects, slopes, and infiltrates runoff and reduces offsite drainage.) Conversion of these areas into turf, motivated by "poor aesthetics" of the original native grass and sedge design, has created a more conventional landscape appearance. The native riparian/upland edge of the original design may be an inappropriate landscape type for small sites. Even if well-maintained, the native grasses and forbs may not be within the cultural norms expected by the public for urban landscapes, even in the environmentally conscious community of Boulder. Articulated by Professor Joan Nassauer, "Novel landscape designs that improve ecological quality may not be appreciated or maintained if recognizable landscape language that communicates human intention is not part of the landscape... Furthermore, the appearance of many indigenous ecosystems and wildlife habitats violates cultural norms for the neat appearance of landscapes. Even to

Lesson: When installing a lowwater-use landscape (whether it comprises native or drought-tolerant species), considering the costs and specialized expertise and requirements for the maintenance and management of the particular species and their contexts is imperative for achieving optimal effectiveness. Specific vegetation maintenance protocols should be developed in parallel with the initial site design, and these protocols should be provided to the client. Ideally, landscape maintenance personnel should be included in the design process, and design and maintenance decisions should be made collaboratively between the contractor. engineer, landscape architect, and owner.

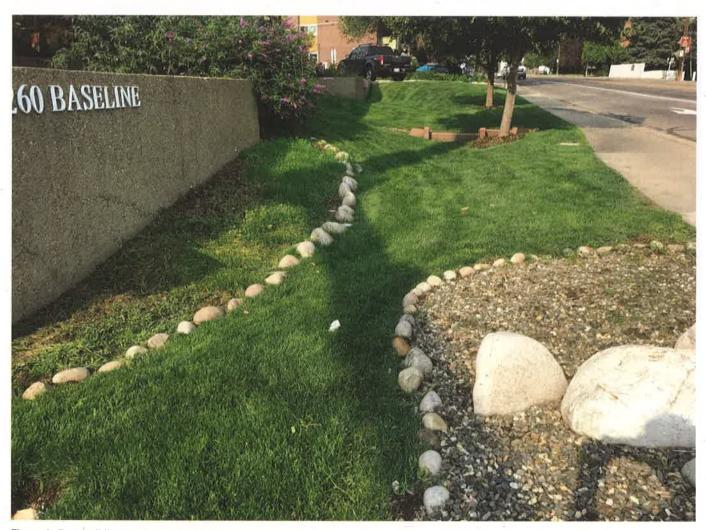
Figure 6. East building landscape in 2017

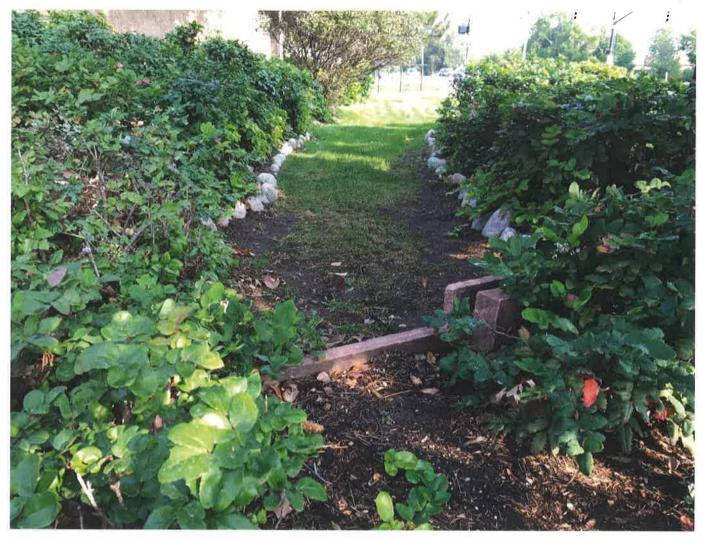
Figure 7. One of three water storage check dams/weir structures installed on the east perimeter of the WRA property to increase onsite stormwater capture volume. Date: 2017.

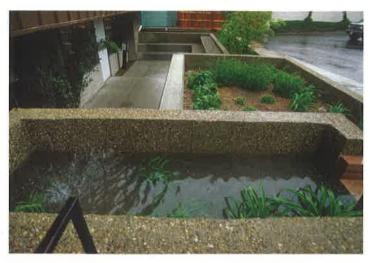
ing. This infiltration garden appears to function as originally designed: It captures water from the roof's western downspouts, promoting infiltration and detaining water for vegetation irrigation needs. Although the building

occupants note that they take great pleasure in watching water fall from the downspout into the detention pool, they observe that the xeriscape plantings used in the planters have been damaged by the splash and flow of stormwater falling from the roof. They also note that the primary detention pool's weir height is too high to allow surface

water to drain out of the pool into the adjacent planting beds in all but the most intense precipitation events. Only minor sedimentation from material carried in roof runoff has occurred in the pool.

Figure 8. Detention pond on western side of ECR building receiving runoff from the building's roof. The pond empties into a xeriscape planter. Date: approximately 1998.

Lessons: Splash should be anticipated and contained so as not to cause unsafe winter icing on walkways. When installing vegetation in detention pools and basins, native and introduced plantings such as sedges, forbs, and similar woody and herbaceous riparian plants that are deeply rooted

and that can tolerate wet and dry cycles and turbulent water should be used in favor of low-water-use plantings. In areas of extreme turbulence, cobbles or large gravel mulch and other nonliving materials should be used to dissipate the energy and turbulence of falling water.

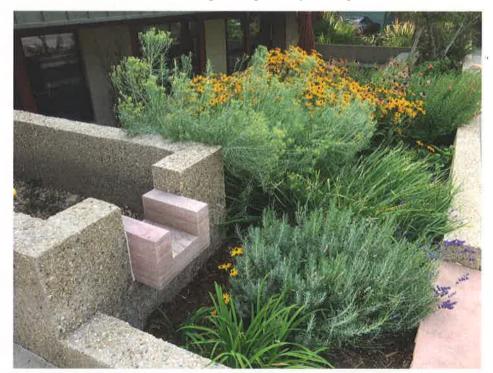
Figure 9. Infiltration gallery with a xeriscape planter on western side of building promotes runoff detention and infiltration. Date: 2017.

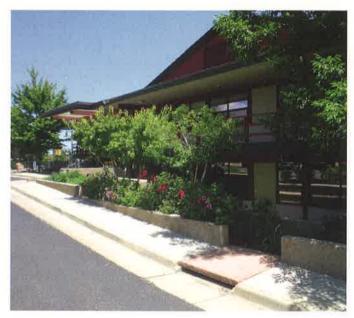
Figure 10. A series of interconnected planters on the building's west side collects and infiltrates roof and parking lot runoff. They have been planted with xeric ornamental plants and trees to shade the outdoor amphitheater and building from hot afternoon sun at the main building entry. These are in contrast to the native plantings that were used in the 1998 landscape renovation along the north and east building edges. Date: approximately 2008.
