Bridging the Gap Between BMP Effectiveness and Receiving Water Quality Protection

This paper presents an approach to evaluating the effects of BMPs on receiving water quality by examining the expansion of the Copper Mountain Base Area in Summit County Colorado, USA.

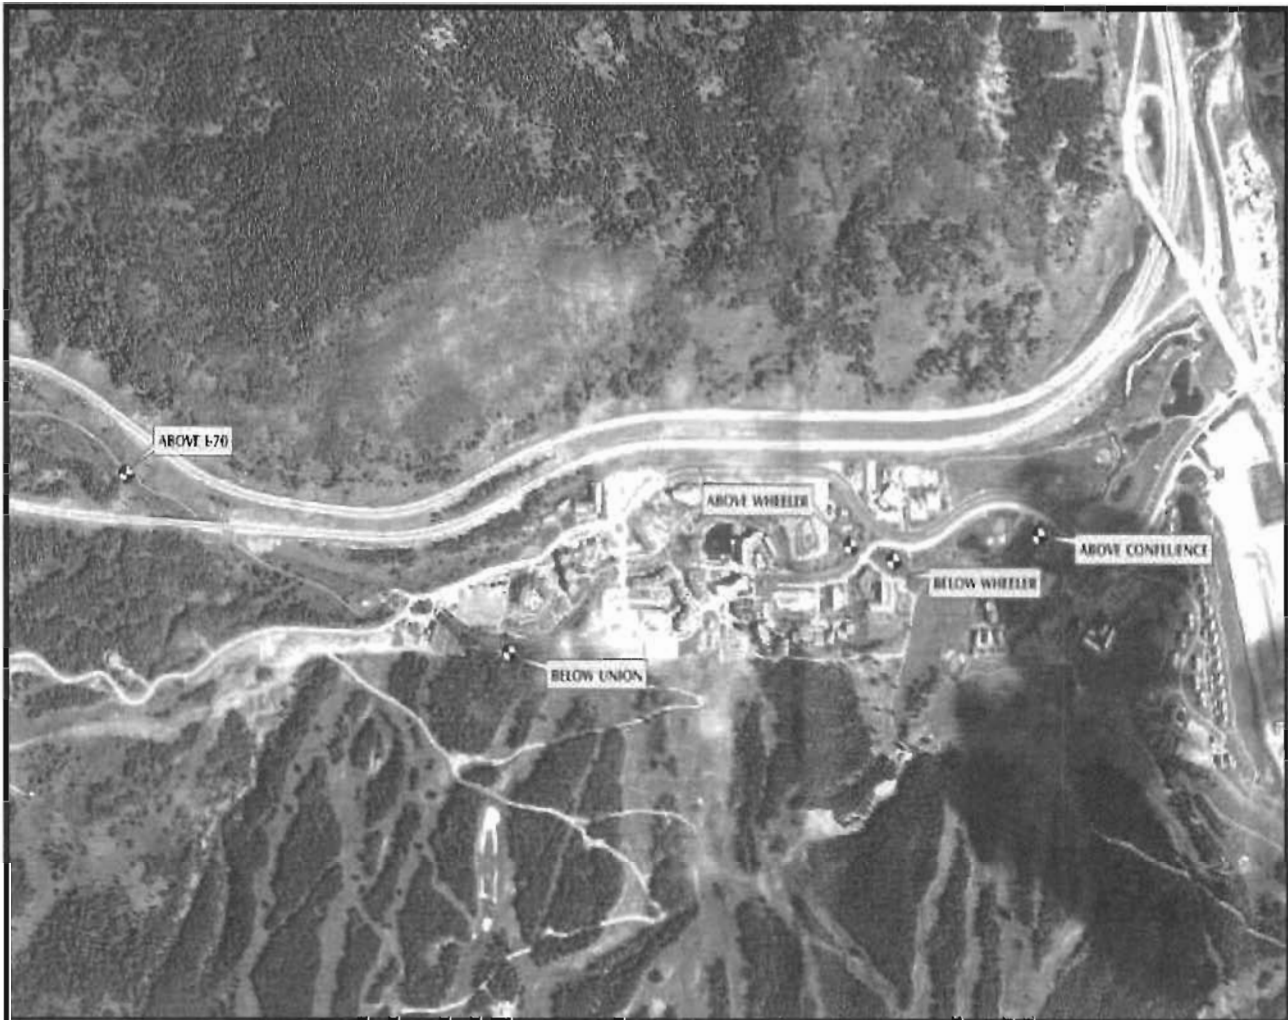
Figure 3. Water Quality Sampling Locations and Approximate Locations of Biological Surveys

Water quality sampling locations are shown on Figure 3. The stations labeled on Figure 3 as "Above I-70," "Below Union," "Above Wheeler" and Above Confluence roughly corresponded to biological monitoring locations WT-1, WT-2, WT-3 and WT-4, respectively. Table 3 contains a summary of the sampling results. Key results of water quality monitoring included:

Biological monitoring of West Tenmile Creek was conducted prior to the start of construction in 1999, during the construction phase of The Village and Passage Point in 2000 and most recently in 2005. Four locations were selected for biological monitoring: one site upstream of Copper Mountain, two sites within the resort Base Area (upstream and downstream of a primary tributary, Wheeler Gulch), and one site downstream of construction activities. The approximate locations of these sites along with water quality sampling locations are shown on Figure 3.
